DESIGN REVIEW AND HISTORIC PRESERVATION BOARD REFERRAL OF APPLICATION

Project Description: Applicant is requesting a Certificate of Appropriateness, pursuant to Code Section 185-196, to replace windows on the second floor of the dwelling. This property is zoned MATZ (Monroe Avenue Transitional Zone) and is designated historic.

**RE: 3577 Monroe Avenue,
Parcel Tax ID #151.13-1-32
2nd Story Window Replacement**

February 4, 2019
Work Description
Second-Story attic window
replacement
3577 Monroe Avenue

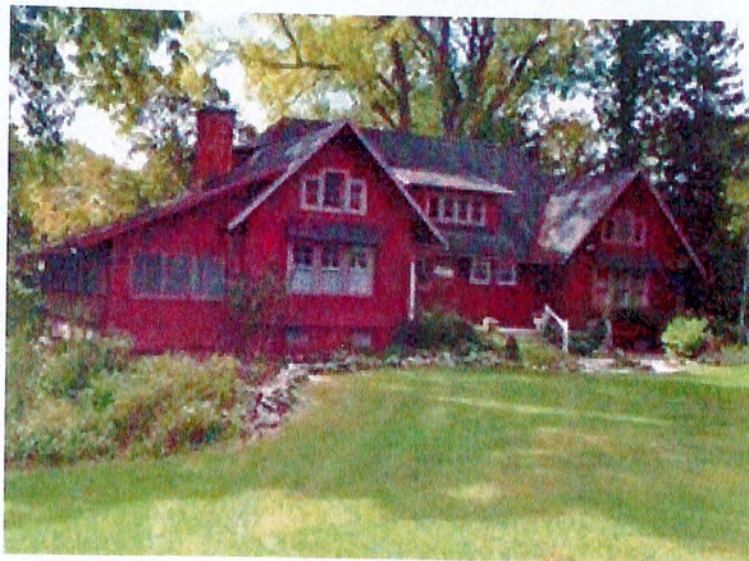
The owners desire to finish the spacious attic into a living space possibly reusing the casement windows. The in-opening, multi-paned sashes are in very good condition and the openings are equipped with separate out-opening (hinged) storm and screen sashes. The window jambs and sills are mostly in good condition although I saw some that were warped at the vertical sides. The sashes do not have weather-seals. Because this was an attic, the sashes were hung with the cheapest possible hardware and some of the sashes do not fit the jambs appropriately.

- Sashes are inspected for warp* and condition (if warped – evaluate for repair or replace)
- All hardware is removed and new mortise hinges are installed
- Latching hardware that works with new interior trim is installed
- Casement stays are installed to hold the windows open
- Frames are repaired or shimmed to fit sashes
- Broken panes of glass are replaced
- Any excessive paint that prevents sashes from working appropriately is removed
- Glazing as necessary, painting, and interior finishing

The wood framed storm and screen sashes were designed to be switched between seasons and appear to be in reasonably good condition. Another solution with the in-opening casements is to convert the existing storms into single-light, permanently installed units with storm and screen panels that are removable from the inside.

Finally, my last 20 years has been all about saving old windows and I seldom see one that can't be repaired. In this case, although the sashes are in good condition, the windows were not designed or installed to be used in a living space and will require a lot of work (tweaking) and new hardware to make them suitable for your needs. You need an experienced "old-house" carpenter to do this satisfactorily. You may want to compare the cost of a rehab vs. the cost of new simulated divided light, wood windows that match the dimensions of your existing windows to present to your preservation commission. I think this is a reasonable request.

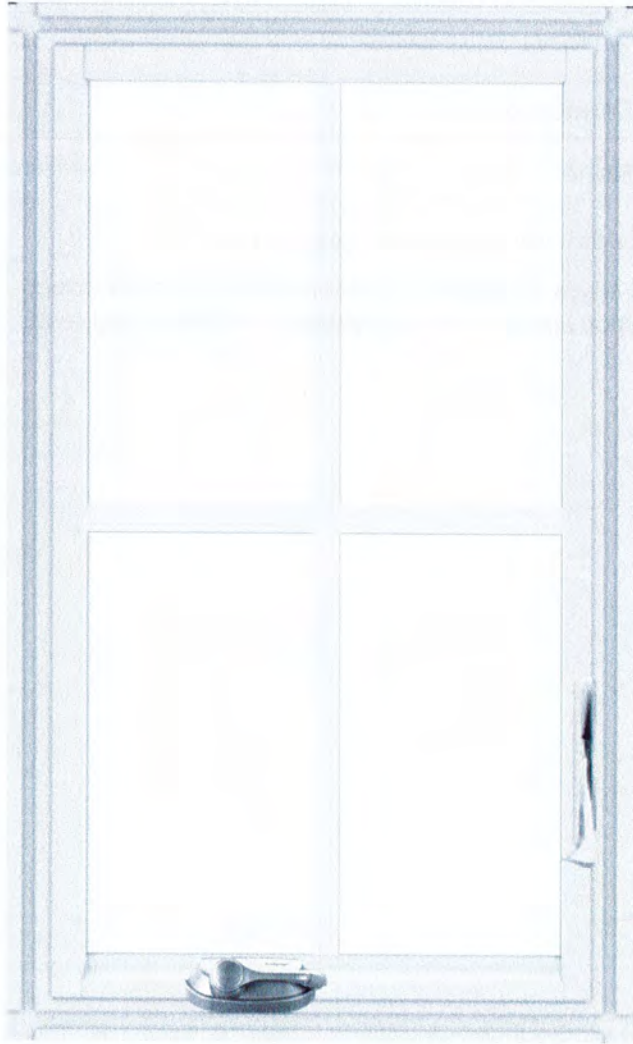
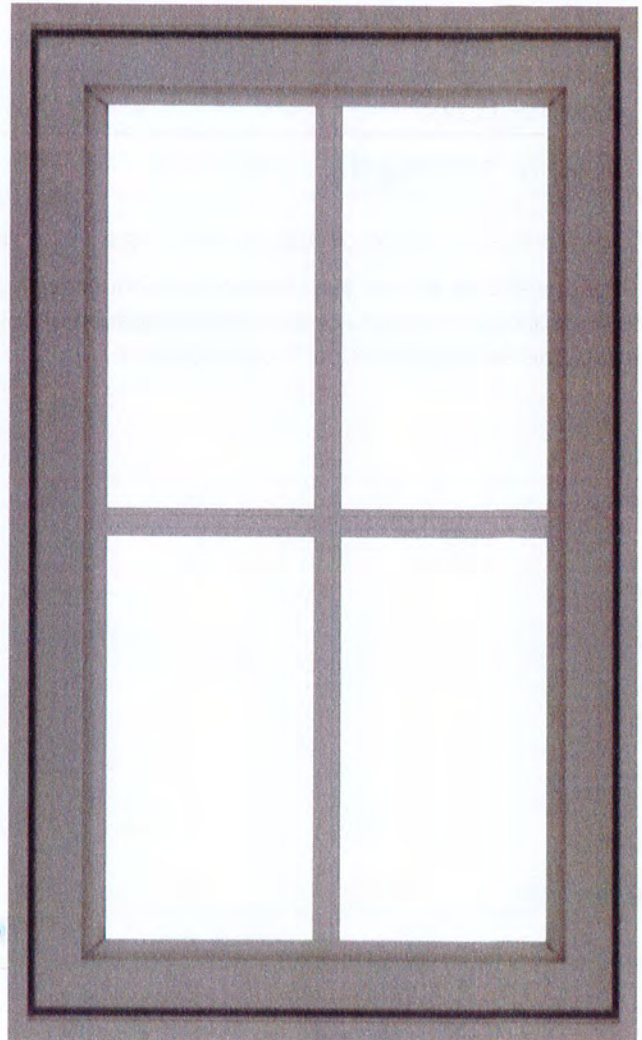
Product Name	400 Series Casement Window
Product ID#	CR125
Unit Width	17"

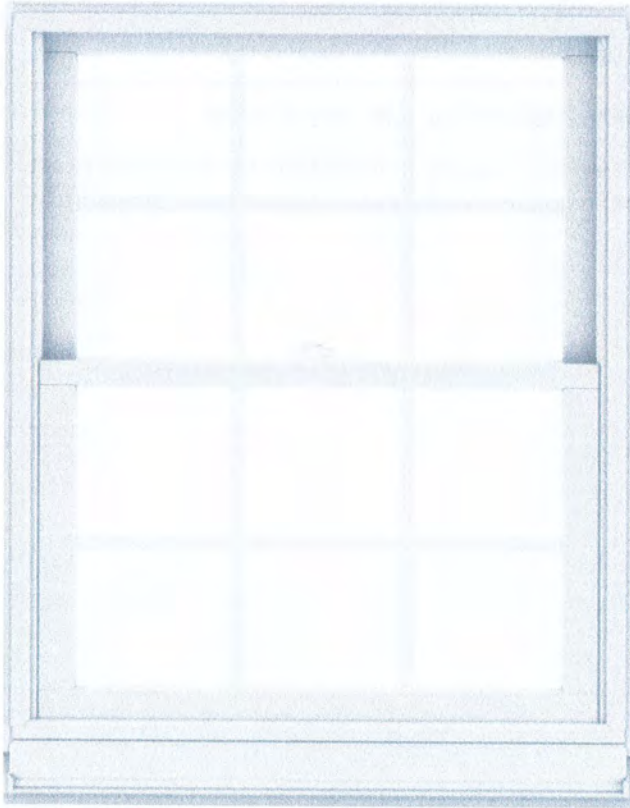
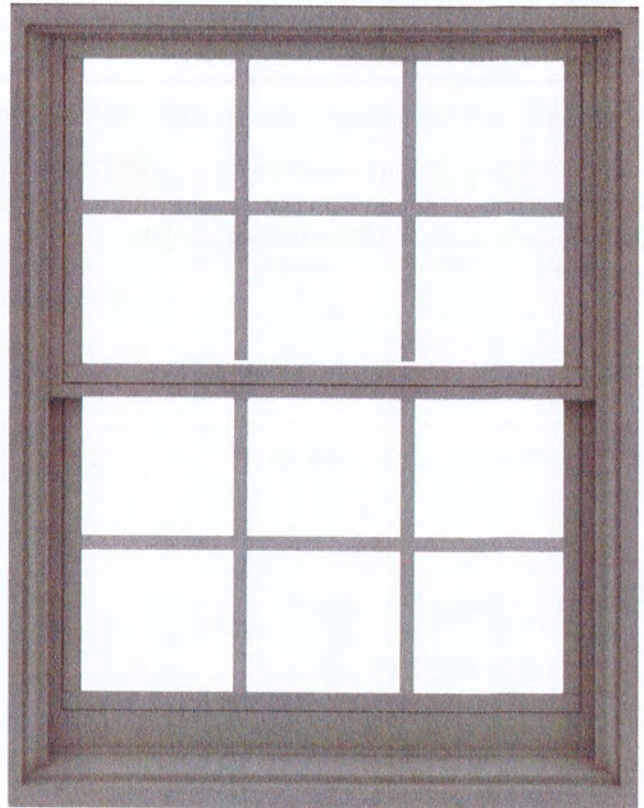
Product Name	400 Series Double-Hung Window
Product ID#	TW2632
Unit Width	31 5/8"
Unit Height	40 7/8"
Interior Color	White
Glass	Low-E4® Glass

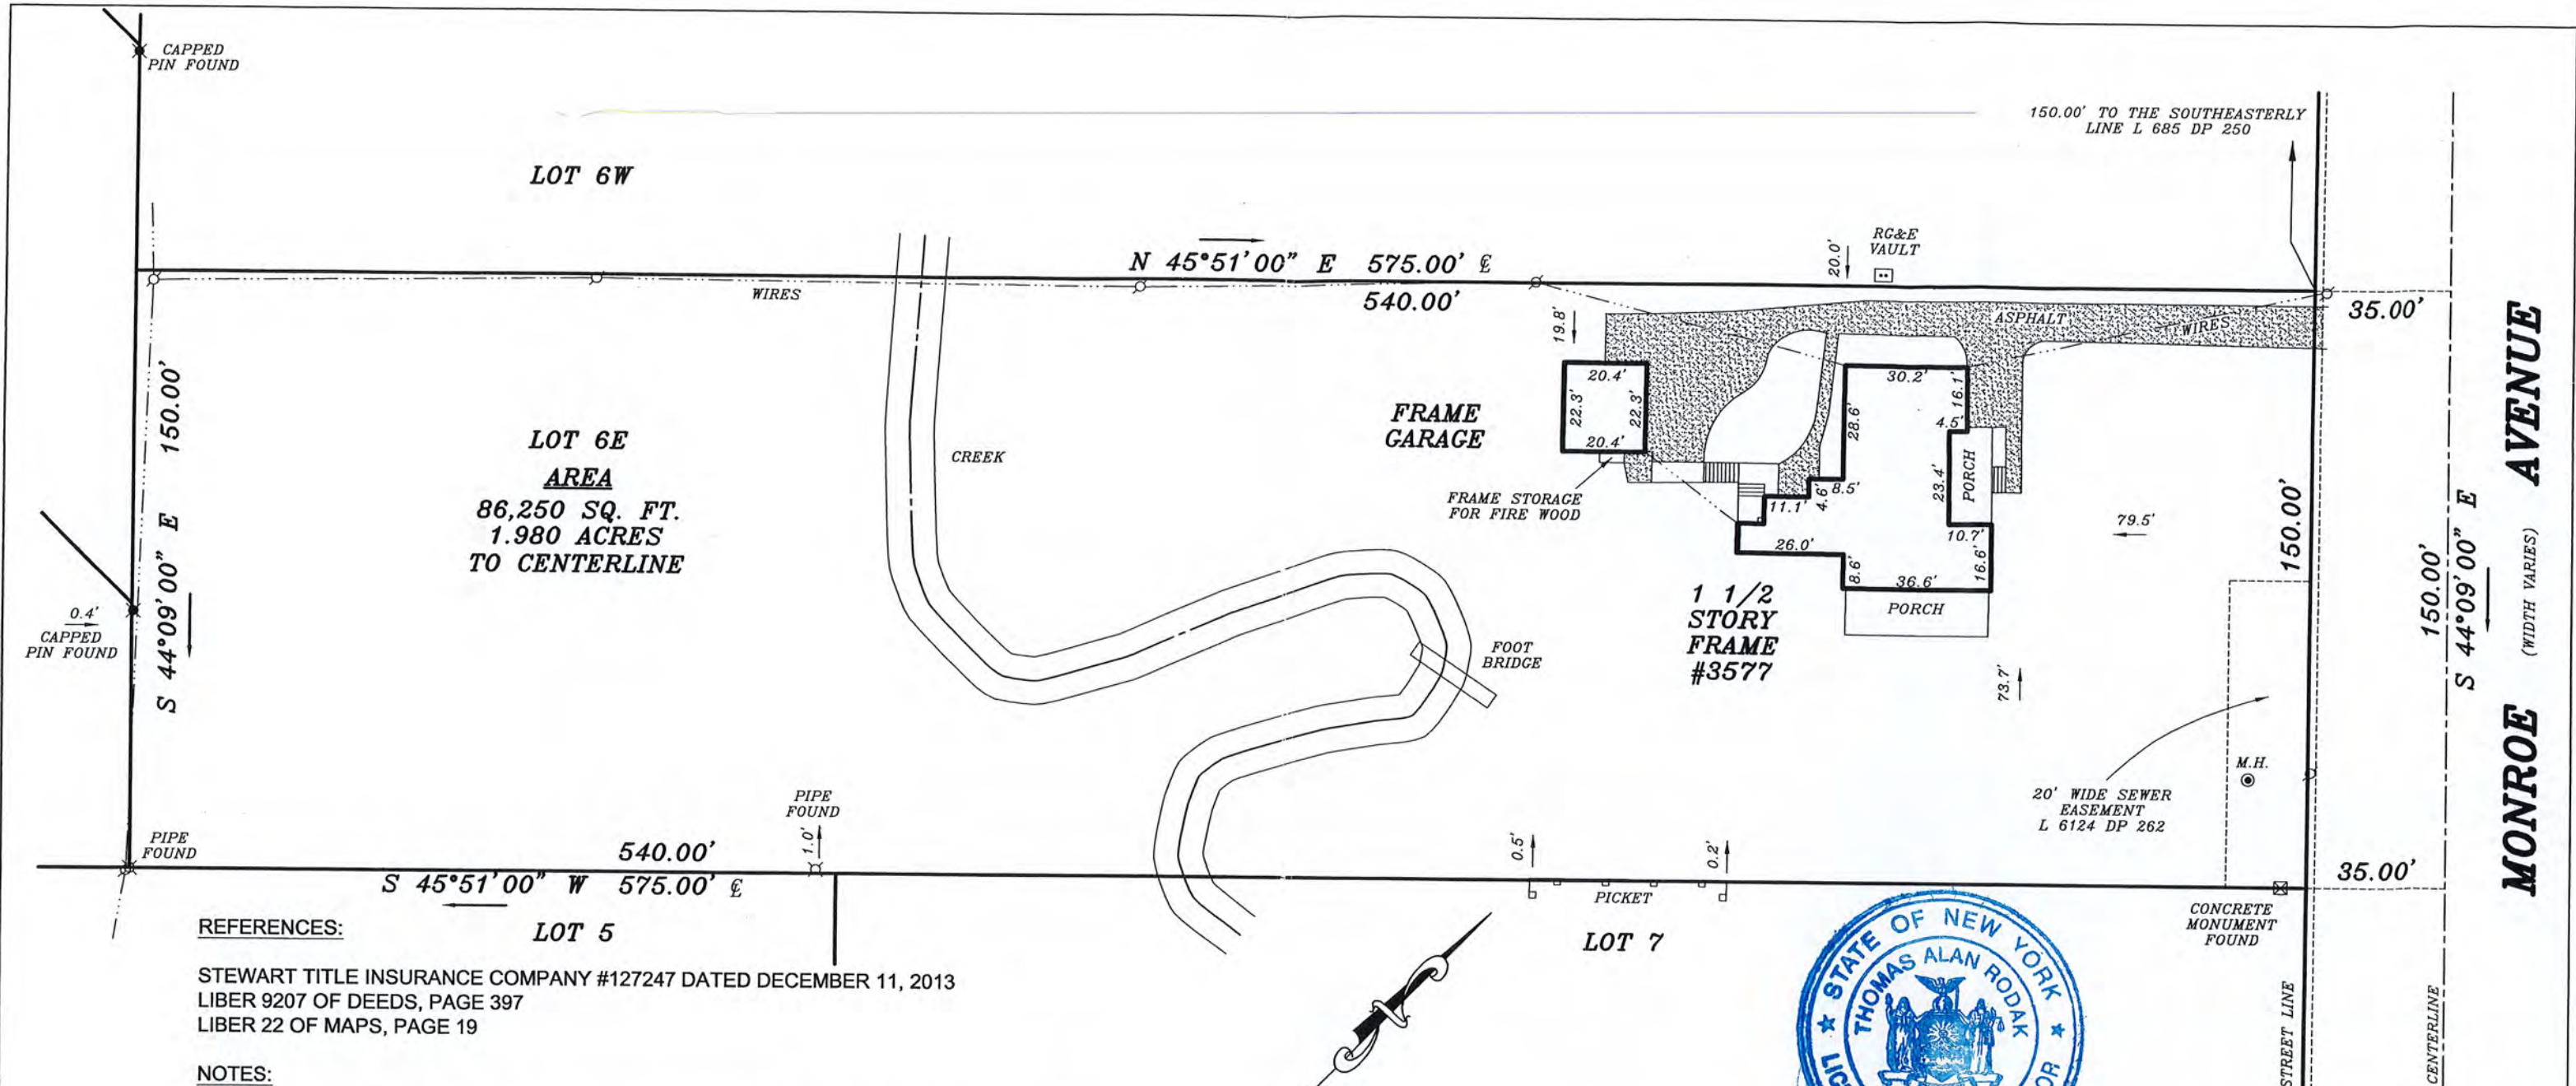
MAP OF A SURVEY		
LOT 6E		
LONG MEADOW TRACT		
TOWN OF PITTSFORD		
MONROE COUNTY, NEW YORK		
CLIENT	WOODS OVIATT GILMAN LLP	
SCALE	DATE	PROJECT NO.
1" = 40'	01/27/2014	2013-1022

MONROE AVENUE
(WIDTH VARIES)

LOT 6E
AREA
86,250 SQ. FT.
1.980 ACRES
TO CENTERLINE

1 1/2
STORY
FRAME
#3577

FRAME
GARAGE

FRAME STORAGE
FOR FIRE WOOD

FOOT
BRIDGE

20' WIDE SEWER
EASEMENT
L 6124 DP 262
