Residential Styles Guide

The following pages include information on basic residential architectural styles found within the Town of Pittsford. The purpose of this guide is to help protect the architectural character of the town by providing planning officials and homeowners with information about the character of residential styles when considering changes to homes. The Guide is meant as a preliminary reference only, and the utilization of additional resources is encouraged.

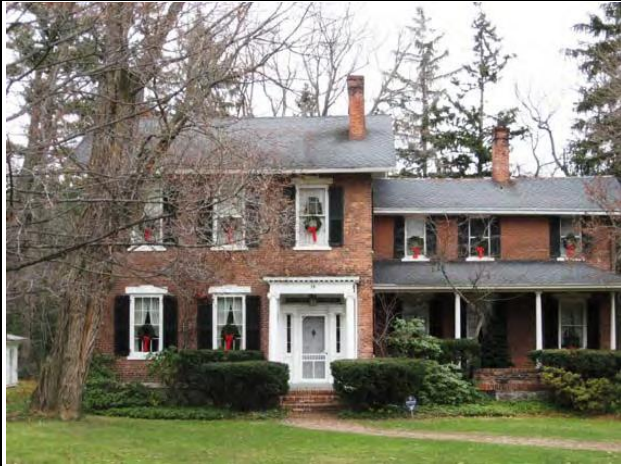
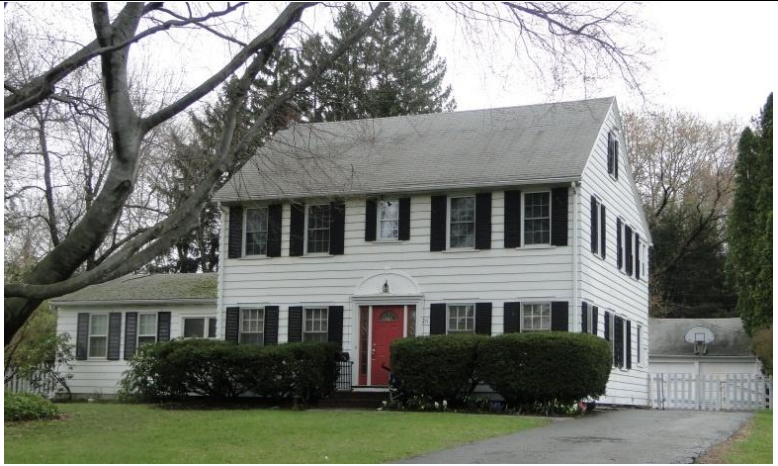
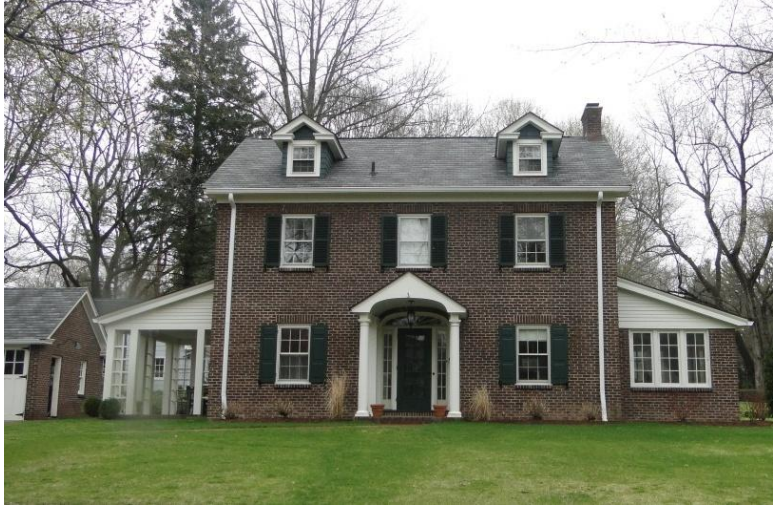
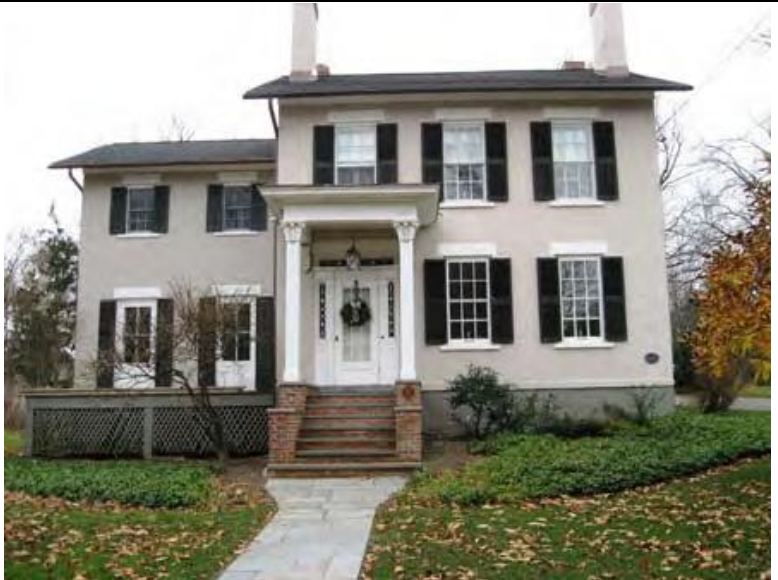
Federal

Design: Three-bay facade with side entrance on most homes. Five-bay symmetrical center entrance on larger houses. Usually symmetrical facade layout.

Height: 1-1/2 to 2 story.

Materials: Brick or wood clapboard.

Roof: Moderate roof slope with cornice returns, full pediment gable, or stepped gable.

Porch: Typically a single bay porch at the entrance, supported by slender Tuscan columns.

Windows: Double-hung with 12-over-12 or 6-over-6 sash, uniform size and regular, symmetrical spacing.

Doors: Six-panel doors with sidelights and rounded fanlight transom window above. Simpler homes may have a projecting transom cornice over the door.

Details: Elliptical and semi-elliptical fanlights on gable ends. Multiple chimneys near gable ends or one central chimney.

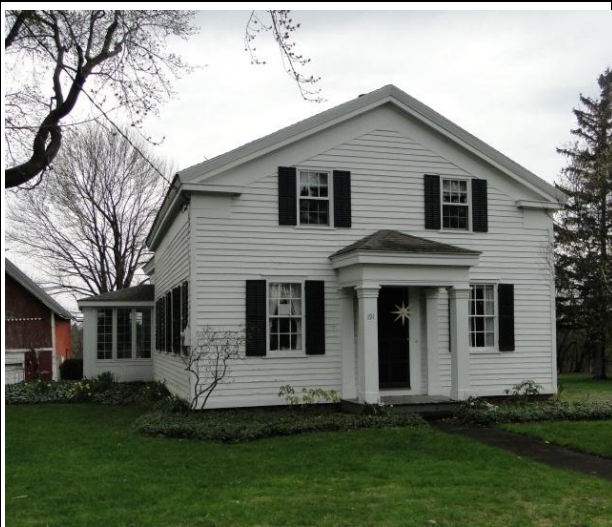
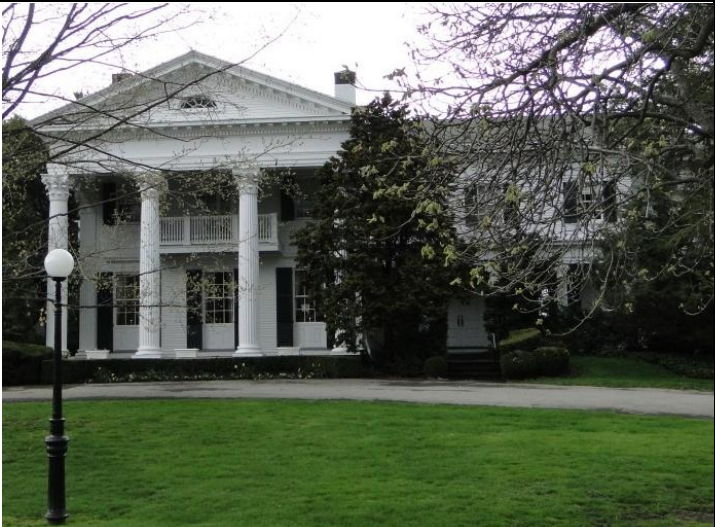
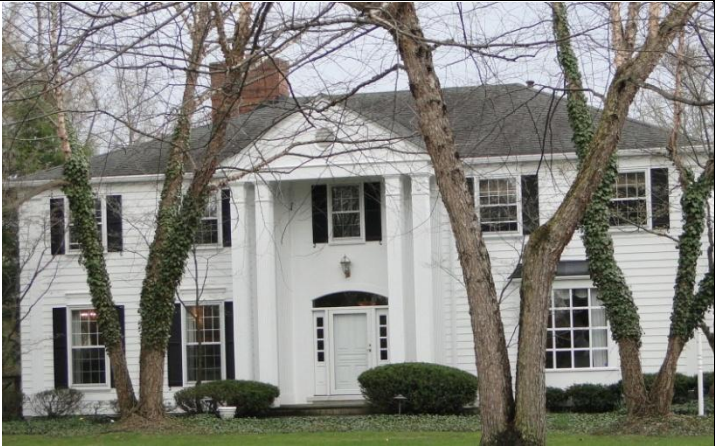
Greek Revival

Design: 3 bay facade with side entrance or center entrance, or 5 bay symmetrical center entrance.

Height: 1-1/2 to 2 story.

Materials: Wood clapboard, flush board, cobblestone

Roof: Moderate slope with cornice returns, or full pediment gable. Front gable, side gable or hip roof.

Porch: Typically a single bay porch at the entrance, supported by slender Tuscan columns.

Windows: Double-hung with 6-over-6 sash.

Doors: One or two-panel doors with sidelights and transom windows. Often framed by formal pilasters.

Details: Square porch columns with Doric capitals. Porches are more common than on Federal style. Occasional use of corner pilasters can be distinguished from federal style by wider dimensions of pilasters, columns and frieze trim.

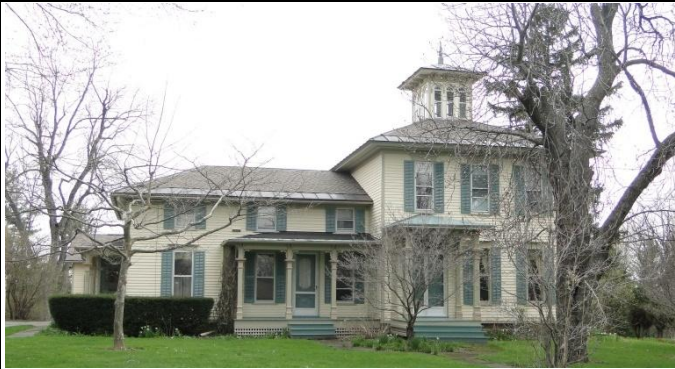
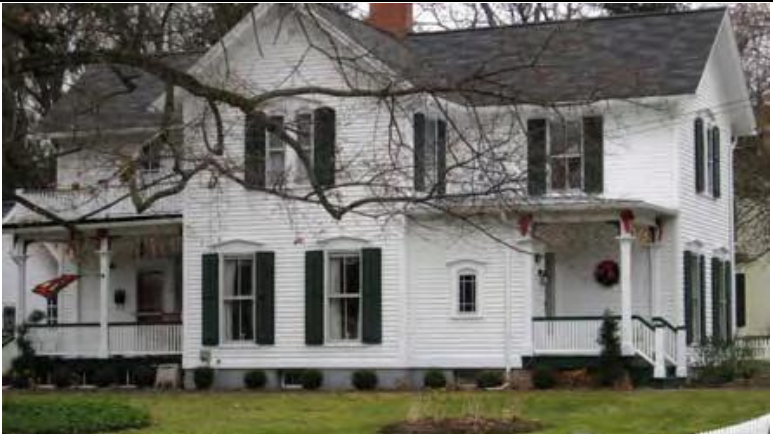
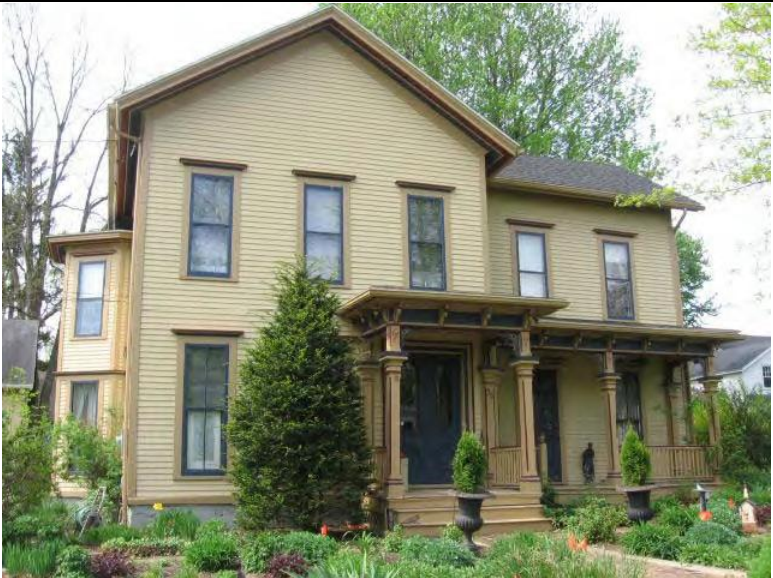
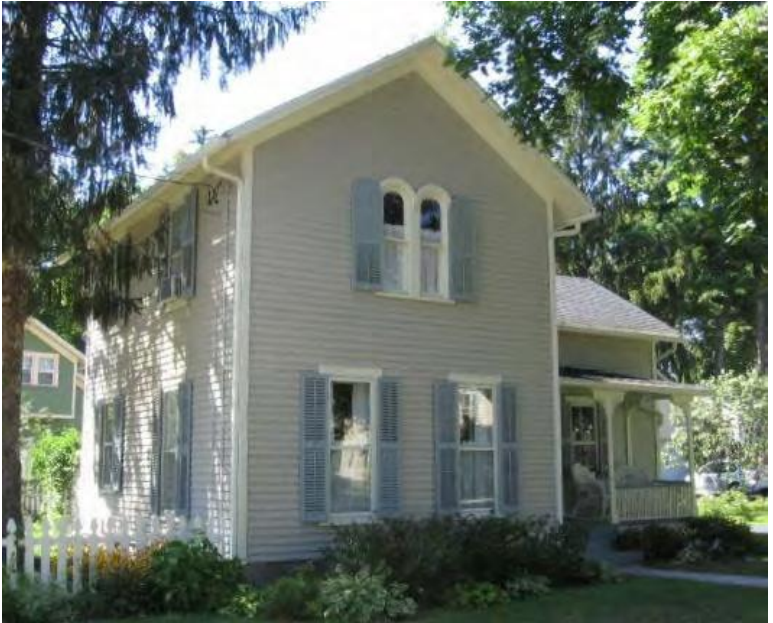
Italianate

Design: Front gable 3-bay with side entrance, gable and wing.

Height: 2 story.

Materials: Wood clapboard.

Roof: Moderate slope with large overhangs, overhanging eaves, often with decorative brackets. Hip roof examples have a very low slope, and sometimes have Belvedere.

Porch: Typically a single bay porch at the entrance. Full width or wraparound porches also common. Columns are often square with chamfered edges, capitals and scroll brackets.

Windows: Double-hung 6-over-6, 2-over-2 or 1-over-1 sash. Windows typically tall and narrow. Double half round windows often found on gable ends of upper floors. Floor-to-ceiling windows common on first floor. Bay windows.

Doors: Double-leaf doors often tall and narrow, with ¾ length glass panels.

Details: Trim and often incorporate bold “rolled” profile moldings.

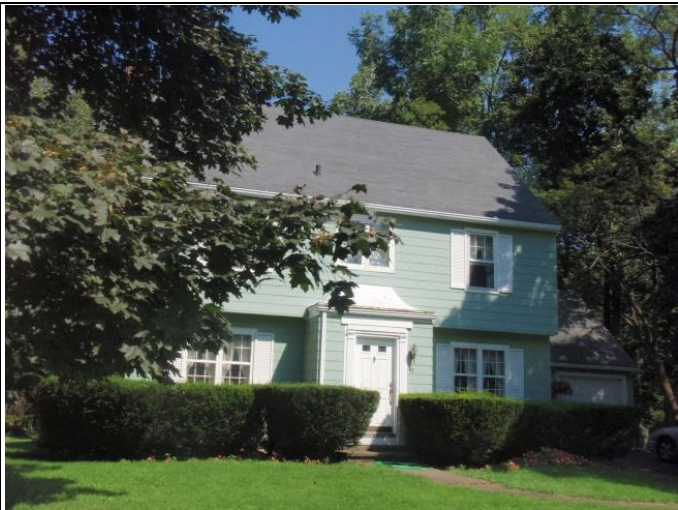
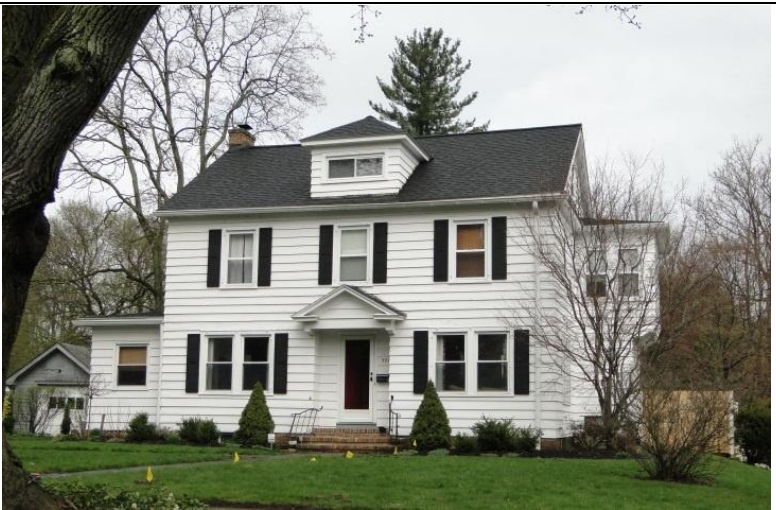
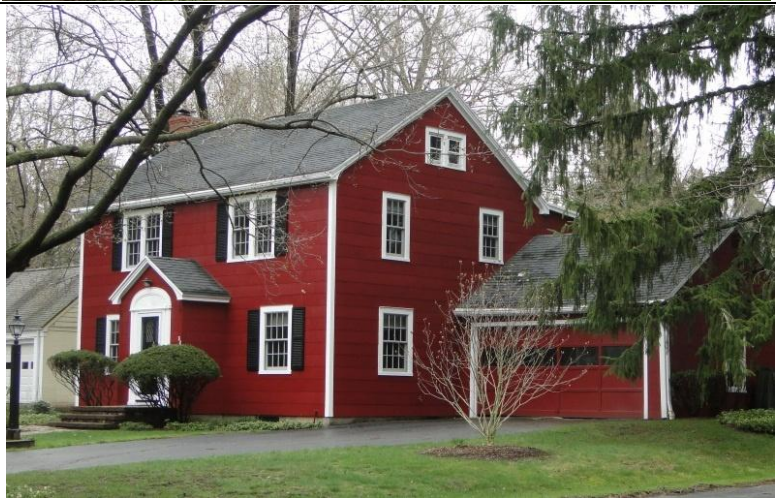
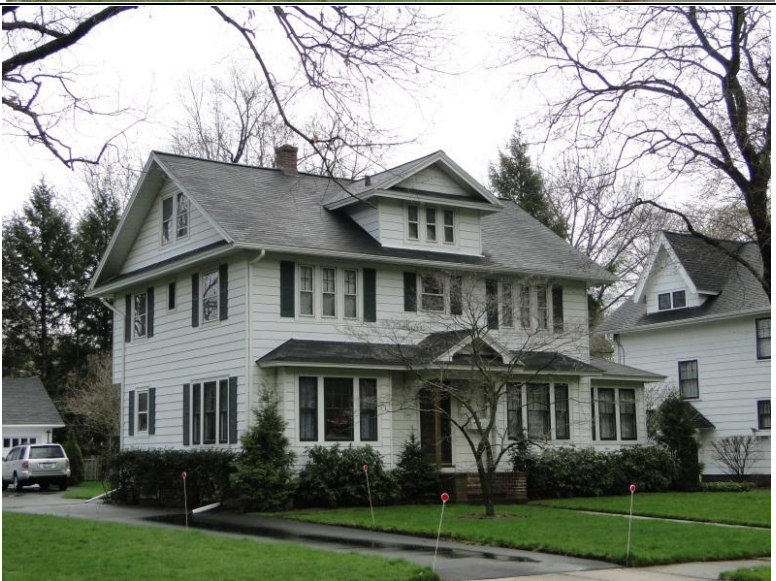
Colonial Revival

Design: Symmetrical 3 or 5-bay facade with center entrance.

Height: 2-story.

Materials: Wood clapboard, shingles, stucco or brick.

Roof: Moderate pitch with cornice returns or full gable pediment, dormers. Typically side gable. Gambrel and hip roofs also found.

Porch: Single bay porch at entry with Tuscan columns or bracket supported canopy.

Windows: Double-hung 6-over-6 or 6-over-1 sash, often with shutters. Uniform size and regular spacing. Bay windows common.

Door: Six panel doors, sometimes with sidelight windows.

Details: Gable-end lunette, exterior chimneys.

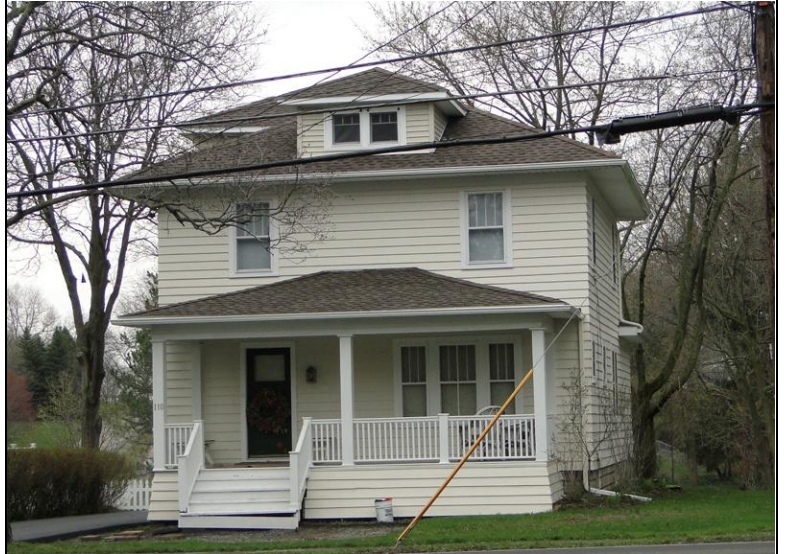
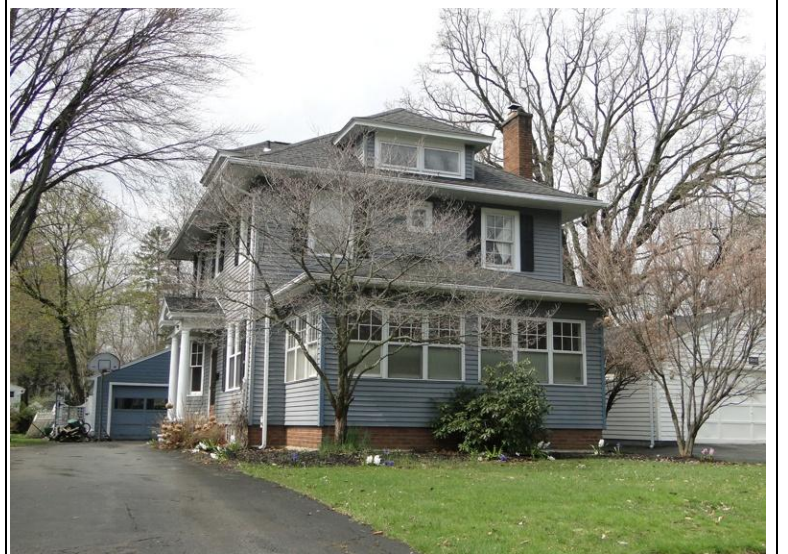
Foursquare

Design: Square or rectangular in footprint, facade often 2 bays wide.

Height: 2-story.

Materials: Wood clapboard, shingles, stucco, brick or rock-face concrete block.

Roof: Steep slope 12:12 pitch gable or hip roof, typically with dormers.

Porch: Typically 2-bay porch covers width of house. Square porch columns or 3/4 height posts set on masonry piers.

Windows: Double-hung 1-over-1 sash. Wide windows of uniform size.

Door: Single door, typically with 1/2 to 3/4 length glass panel.

Details: Upper floors or gable is often separated from facade below by horizontal break or belt course, with change in materials or colors.

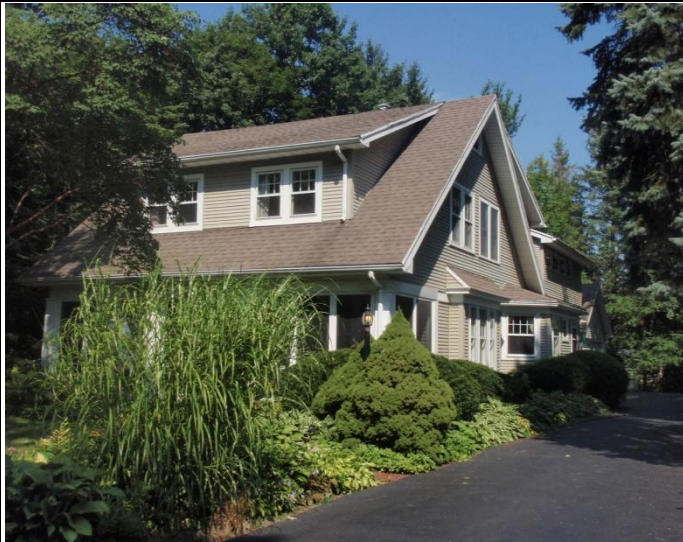
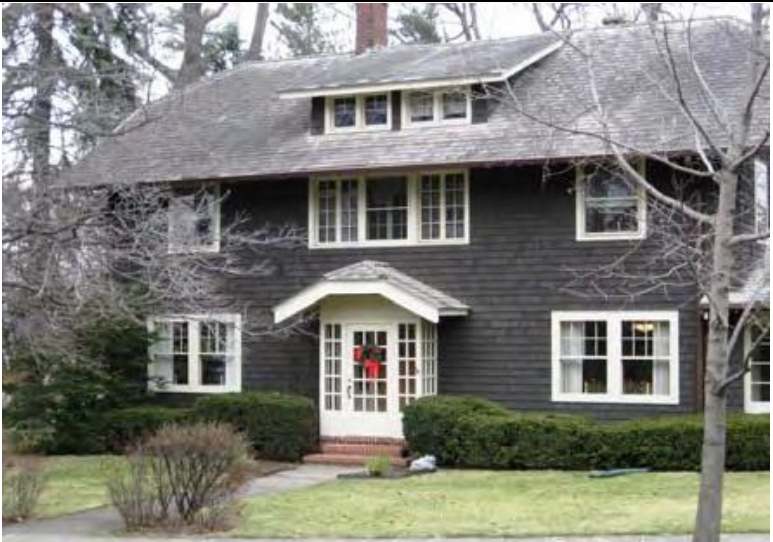
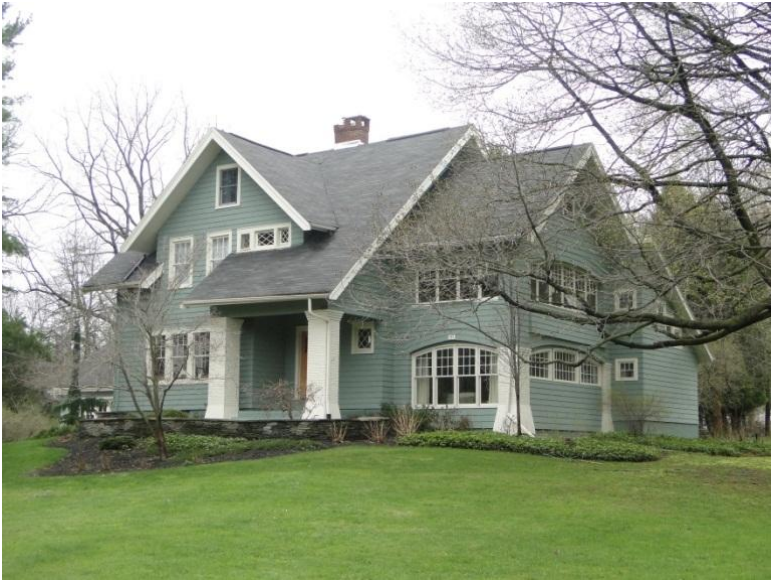
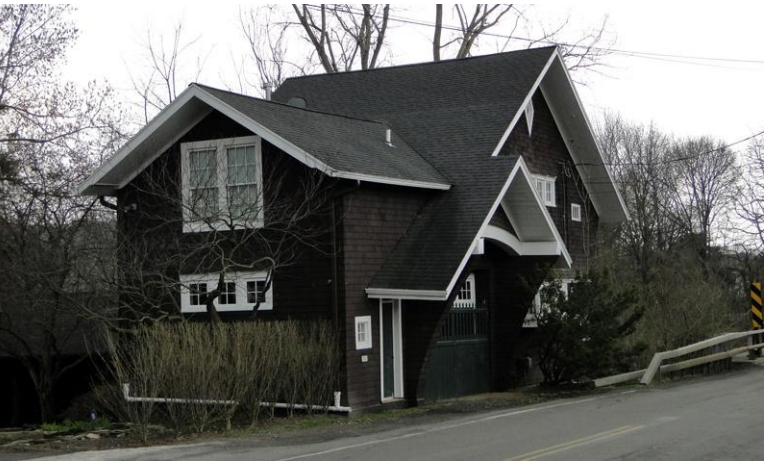
Craftsman

Design: Commonly side gable, square or rectangular in footprint. Some front gables.

Height: 1-1/2 to 2 story.

Materials: Wood clapboard, wood shingle, masonry, brick.

Roof: Moderate slope and pronounced roof. Porch roof is often an extension of primary roof above. Often large shed gable or hip dormer in center of roof. Deep roof overhangs, sometimes with support brackets. Exposed rafter tails.

Porch: Porches are typically full width of facade when present. Porch posts typically are stout square posts set on masonry piers.

Windows: Double-hung with 6-over-6 or 6-over-1 sash, often paired. Some casement windows. Windows vary in size and placement.

Details: Sturdy, simplified appearance with rustic look. Not much ornamentation.

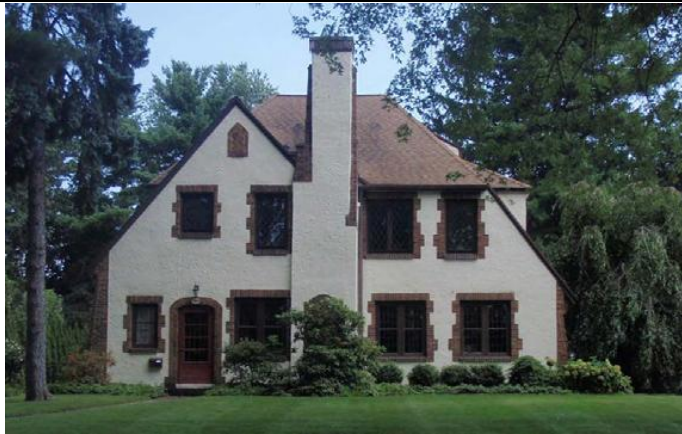
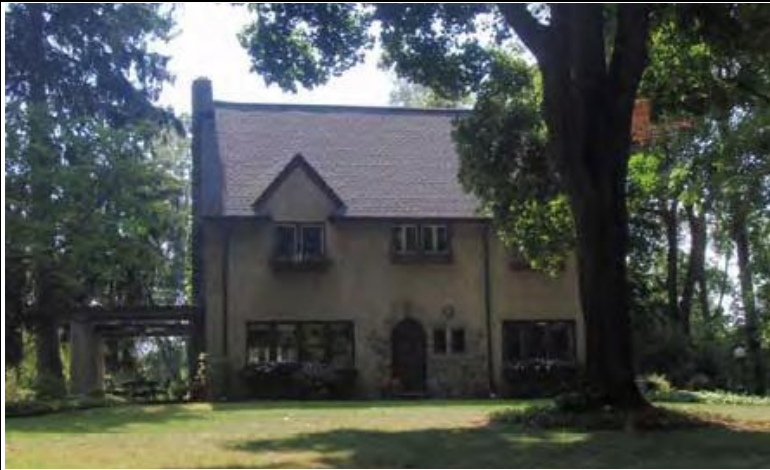
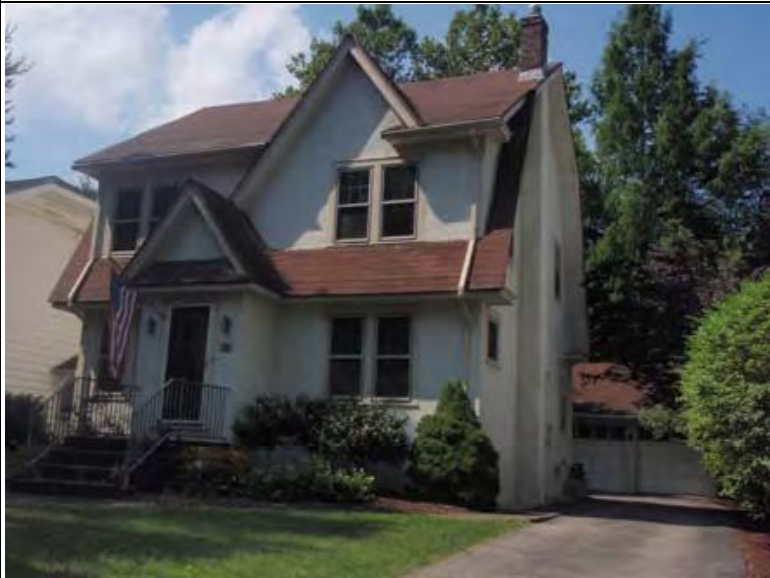
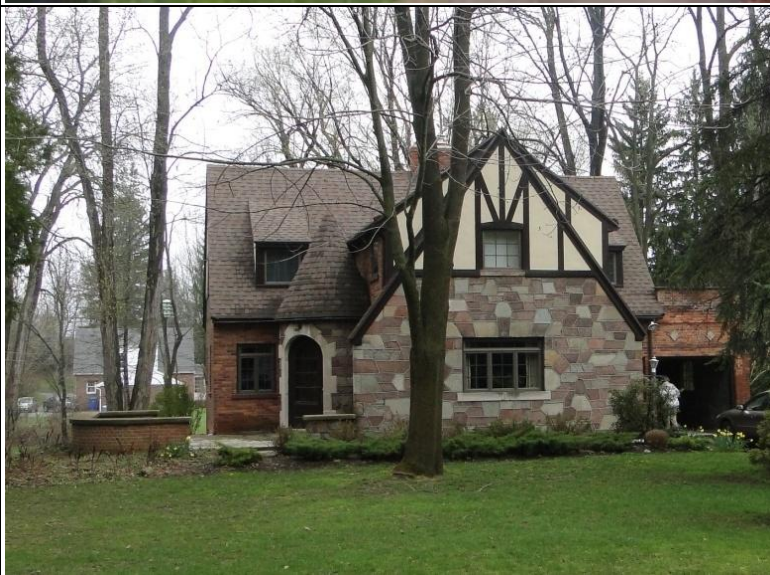
Tudor Revival

Design: Asymmetrical layout, often with small gable over entry.

Height: 1-1/2 to 2 story.

Materials: Stucco, stone, brick or wood shingles, often with a mixture of materials on the same structure.

Roof: Steep slope with little or no overhangs, complex roof forms with multiple gables, shed dormers. Slate roofs are common.

Porch: Small entrance porch, if present, or side porch. Posts and brackets detailed to resemble heavy timber construction.

Windows: Often wide casement windows, paired in 2's or 3's, often with leaden sash.

Doors: Front door is often faced with vertical stained or natural finish wood planks.

Details: English cottage or manor house appearance. Often has asymmetrical gables.

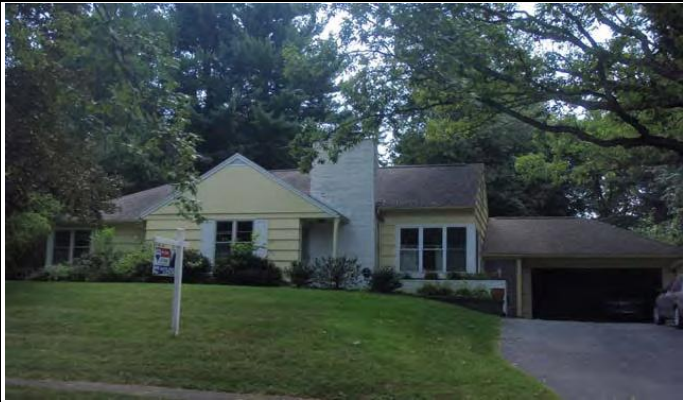
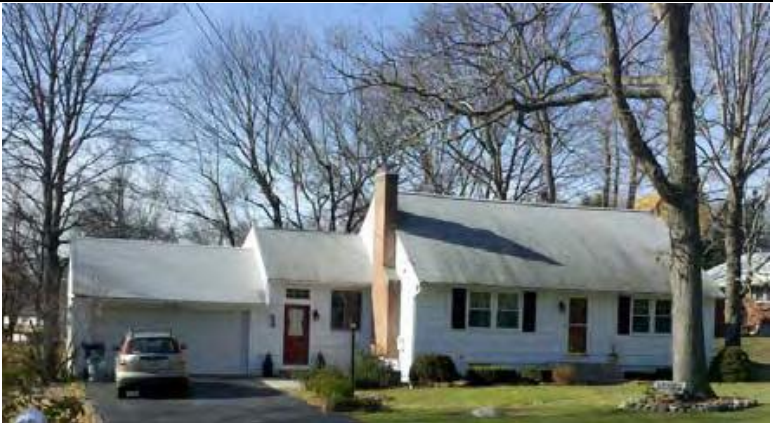
Minimal Traditional

Design: Asymmetrical, with main roofline often parallel to road and gable.

Height: Typically 1-story, some 2-story.

Materials: Wood clapboard, brick, stone, often in a mix.

Roof: Low to intermediate roof pitch. Minimal eave overhangs, minimal or no rake overhangs.

Porch: Some small entry porches with iron or simple wood post supports.

Windows: Double-hung, casement.

Details: Typically has one wide chimney.

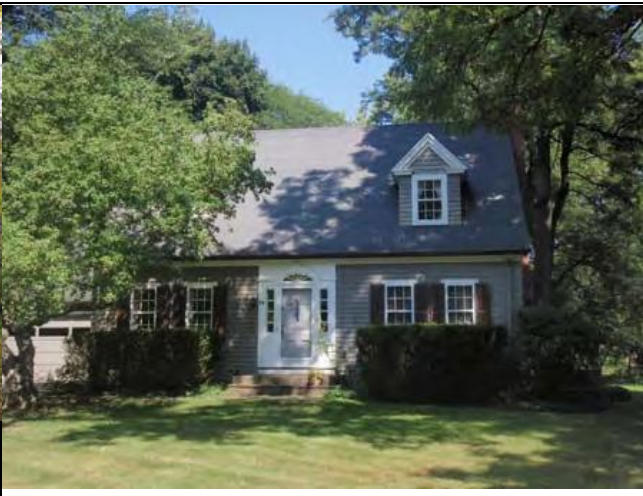
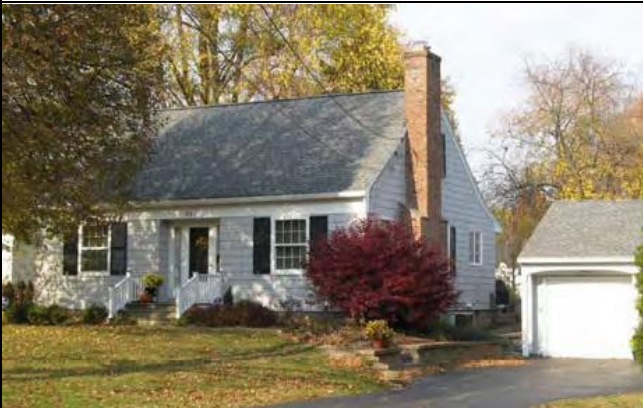
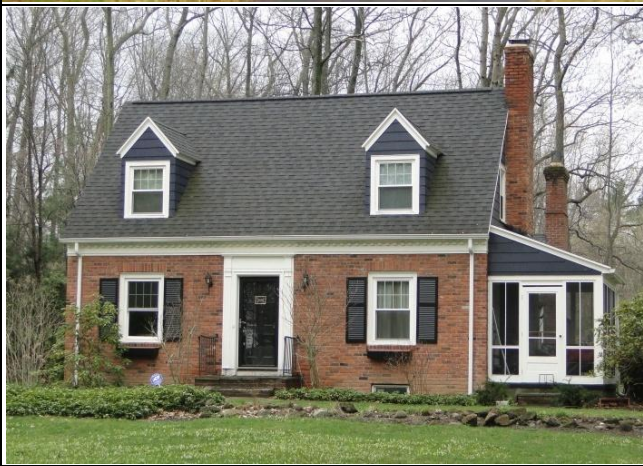
Cape Cod

Design: Ridgeline parallel to road, symmetrical center entrance common.

Height: 1 - 2 story.

Materials: Wood siding (wide clapboard or shingle), may be brick.

Roof: Steep gabled roof, ridgeline parallel to street, with a small overhang and dormers.

Porch: Usually no front porch.

Windows: Relatively tall with small panes, usually double hung.

Door: Paneled wood door with simple Colonial-inspired detail surrounding it.

Garage: Detached, or attached with a breezeway and clearly subordinate to the main house form; earlier examples were built without garages.

Details: Usually simplified Colonial revival.

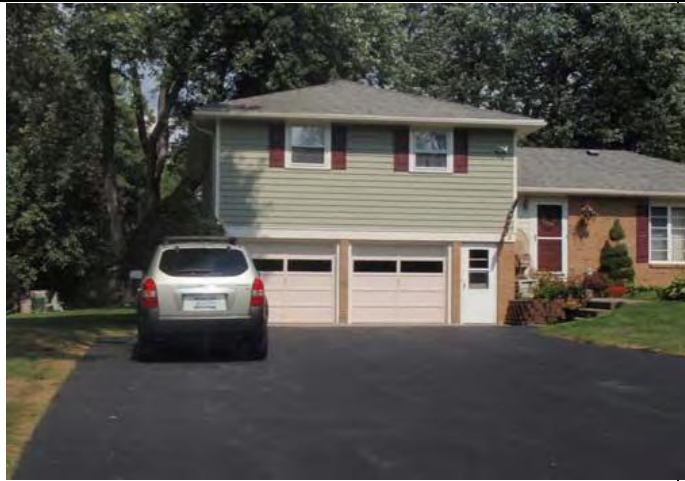
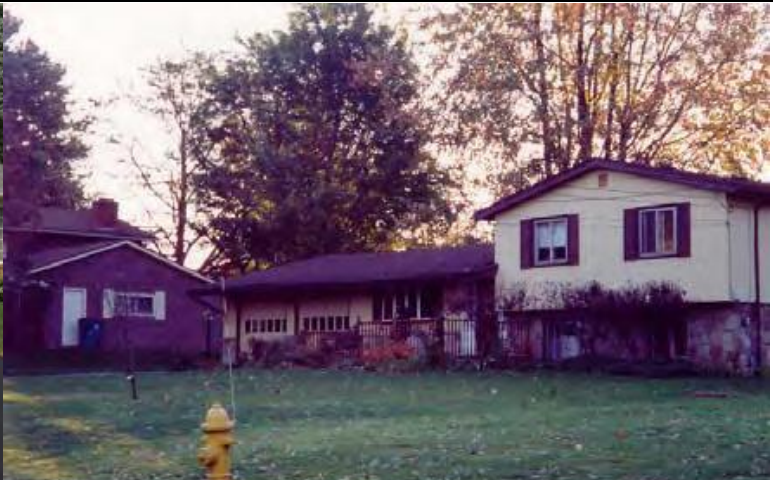
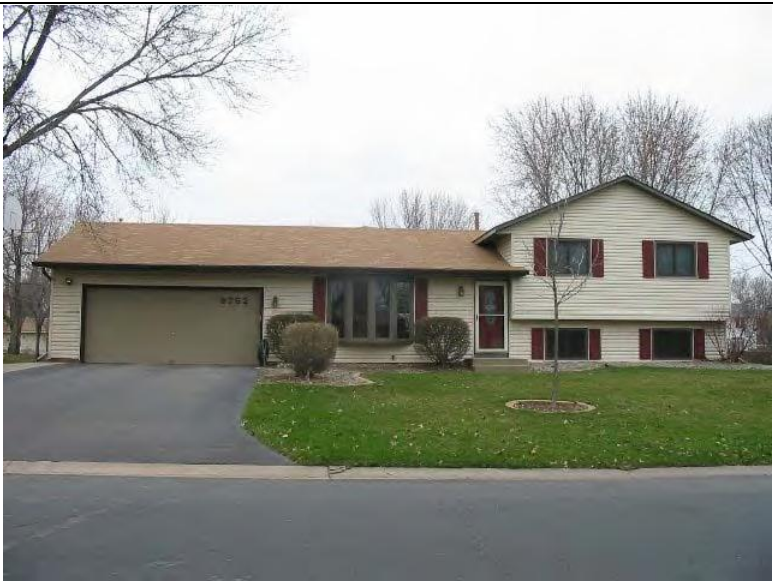
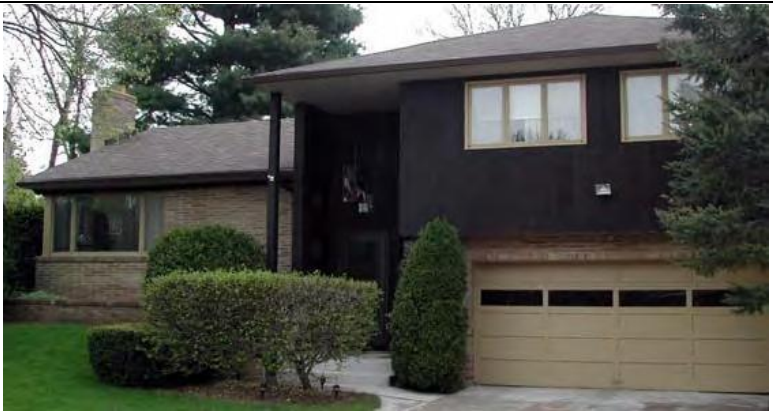
Split Level

Design: Asymmetrical layout, with garage at one end often underneath second story. Two-story section of home is intersected at mid-height with single-story area on one side.

Height: 2 story.

Materials: Wood clapboard, vertical wood siding, stone and/or brick, often mixed together.

Roof: Low to moderate roof slope with medium to wide overhangs. Hipped and side-gabled roof shapes. Asphalt shingles most common.

Porch: Porches uncommon. Small covered entry areas sometimes found which are extension of main roof above.

Windows: Double-hung or casement windows, often with shutters.

Details: Often utilizes mixture of different materials and colors along facade.

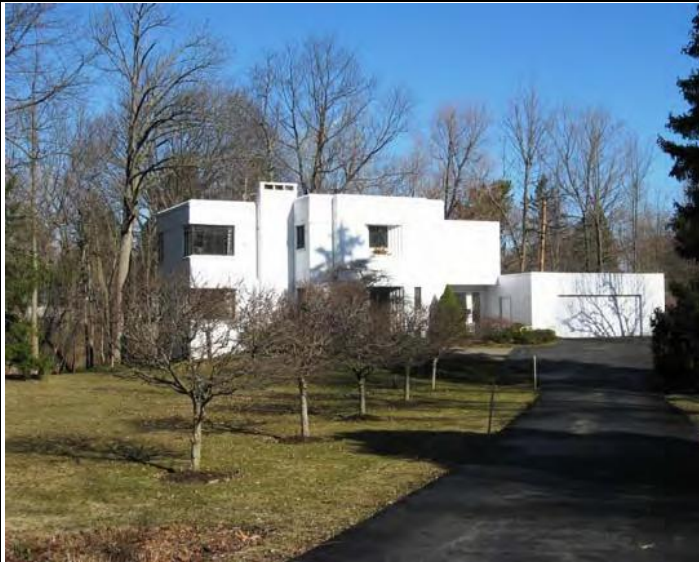
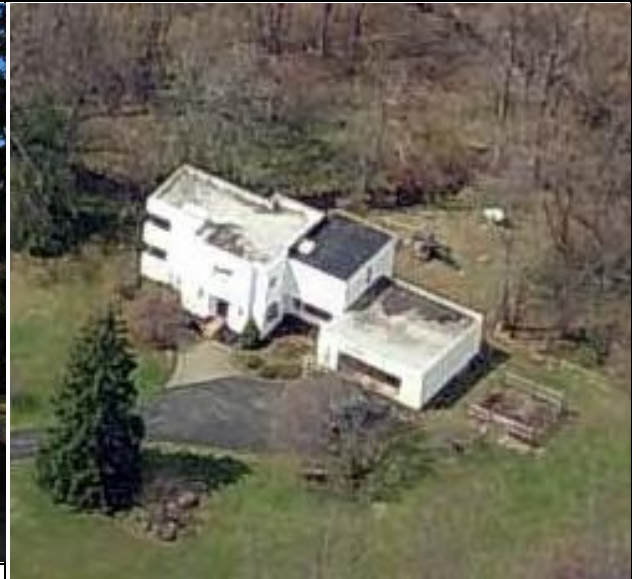
International

Design: Generally simple smooth exterior form and massing with little or no detailing or ornamentation, asymmetrical layout.

Height: 2 story.

Materials: Smooth exterior surfaces, typically stucco, without ornamentation or detailing.

Roof: Flat roof without any edge detailing or coping.

Porch: No porch.

Windows: Picture or gridded windows set almost flush with exterior wall. No trim. Ribbon windows or windows which wrap around corners often found.

Details: Very little ornamentation. Exterior areas which do not have windows are typically left as large blank areas of wall. Use of cantilevered overhangs common.

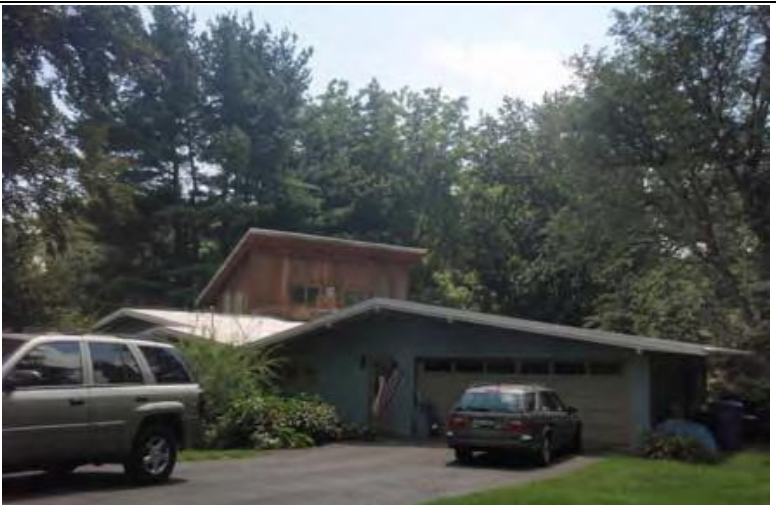
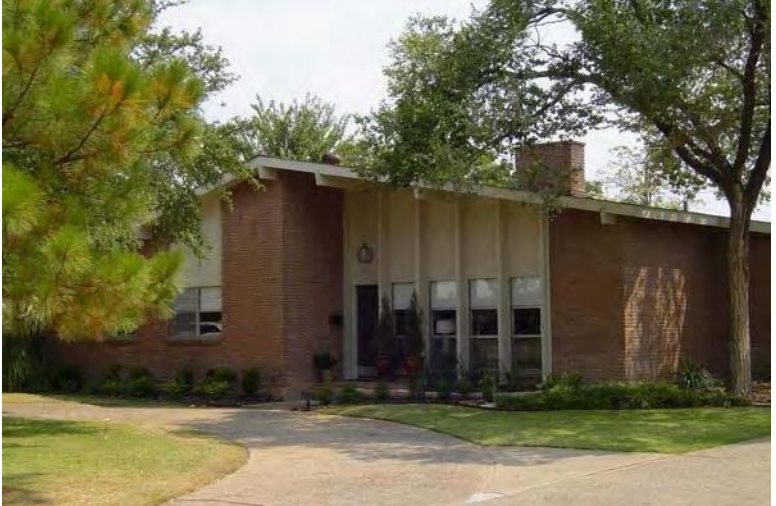
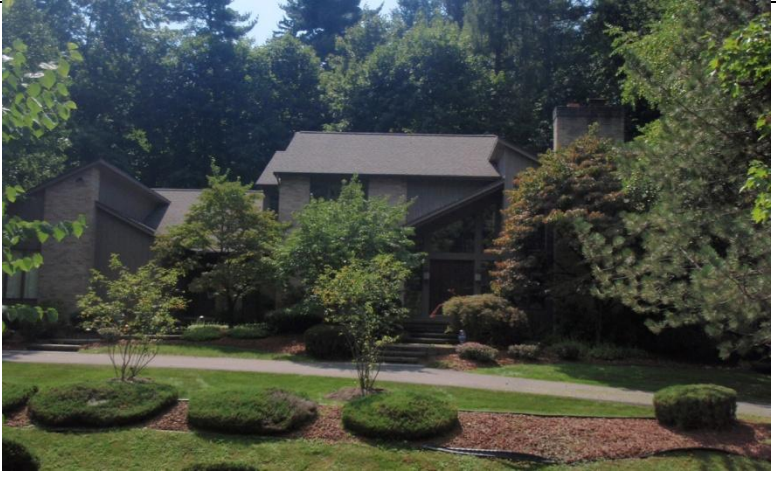
Contemporary

Design: Asymmetrical layout.

Height: 1 – 2 story.

Materials: Typically vertical wood siding, stone or brick.

Roof: Low to moderate roof slope with overhanging eaves, often with exposed rafter tails. Asphalt shingles most common. Some flat roof examples.

Porch: Small covered entrance area sometimes found, often with roof which is an extension of main roof above.

Windows: Typically wide picture or casement windows.

Details: Exposed rafter tails or roof beams. Asymmetrical gable shapes, where one side of gable is cut short.

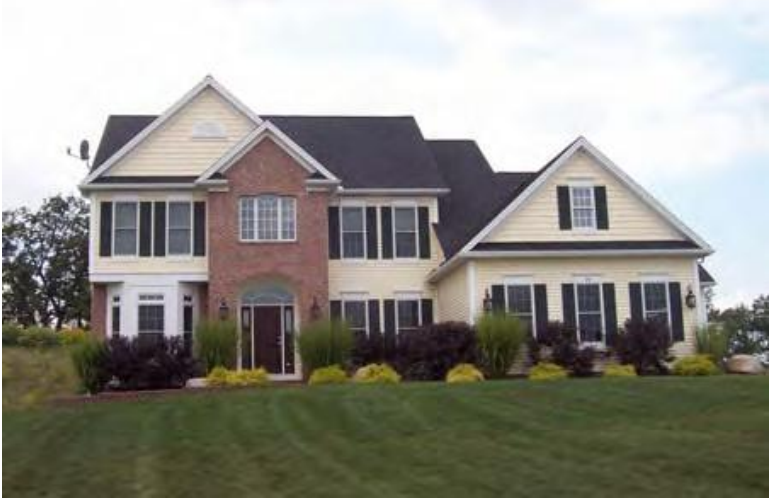
Neo-Traditional

Design: Asymmetrical layout with gabled roof and steep roof pitch, one or more cross gables. Generally imitates traditional styles such as Queen Anne. Attached garage.

Height: 2 story.

Materials: Wood clapboard, often mixed with brick or sometimes stone. Asphalt shingles.

Roof: Steep roof pitch, often with complex forms, hip roof and smaller gables nested inside of larger gables.

Porch: Small covered porch or entry area sometimes found, often with roof which is an extension of main roof above.

Windows: Typically double-hung, simulated divided light, often with decorative (non-functional) shutters.

Details: Full pediment gables.

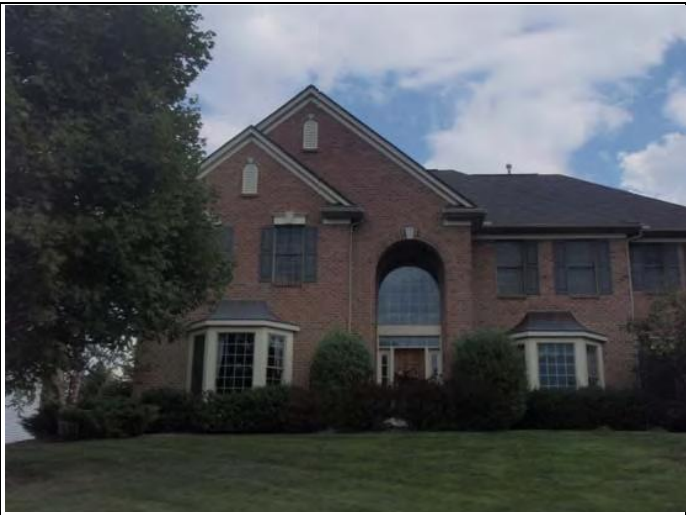
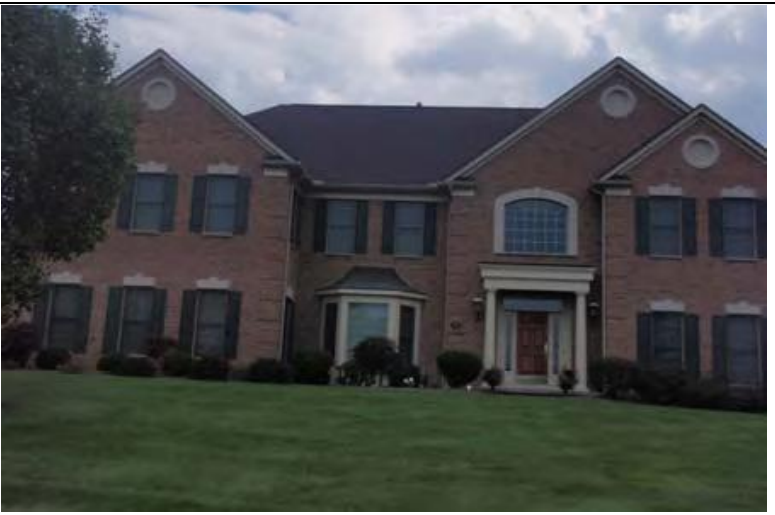
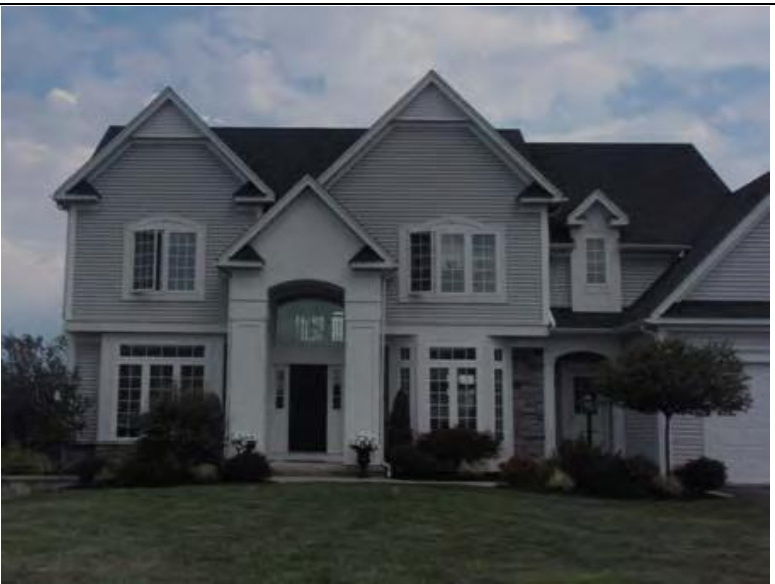
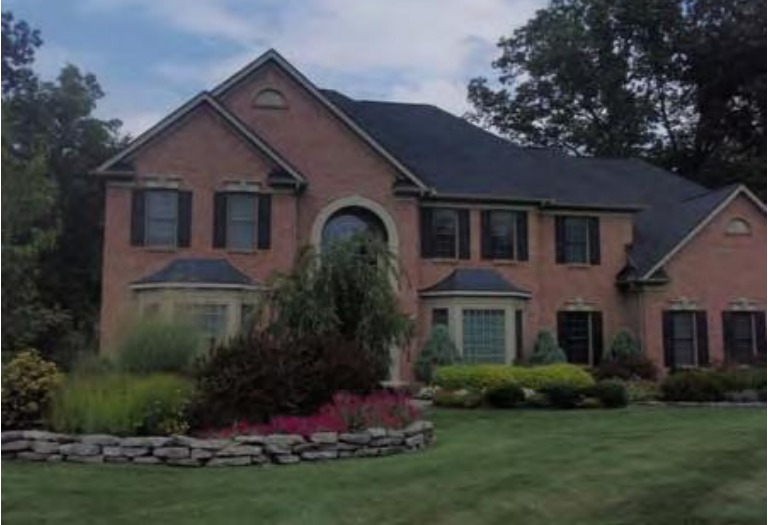
Neo-Eclectic

Design: Asymmetrical layout with prominent front facade, gabled roof and steep roof pitch, one or more cross gables. Attached garage.

Height: 2 story.

Materials: Most commonly brick, with some wood clapboard, sometimes mixed with stone. Asphalt shingles most common.

Roof: Steep roof pitch, broken pediment gable. Roof often made of complex forms, hip roof and smaller gables nested inside of larger gables.

Porch: No porch. Shallow covered or recessed entryway often found.

Windows: Typically double-hung or casement with simulated divided light. Decorative (non-functional) shutters often found. Bay windows common.

Details: Very prominent front entryway, often 2 stories in height highlighted with large windows above and/or flanked by large columns.
