## Town of Pittsford

## Copper Beech Park

Revised Schematic Design

February 10, 2022

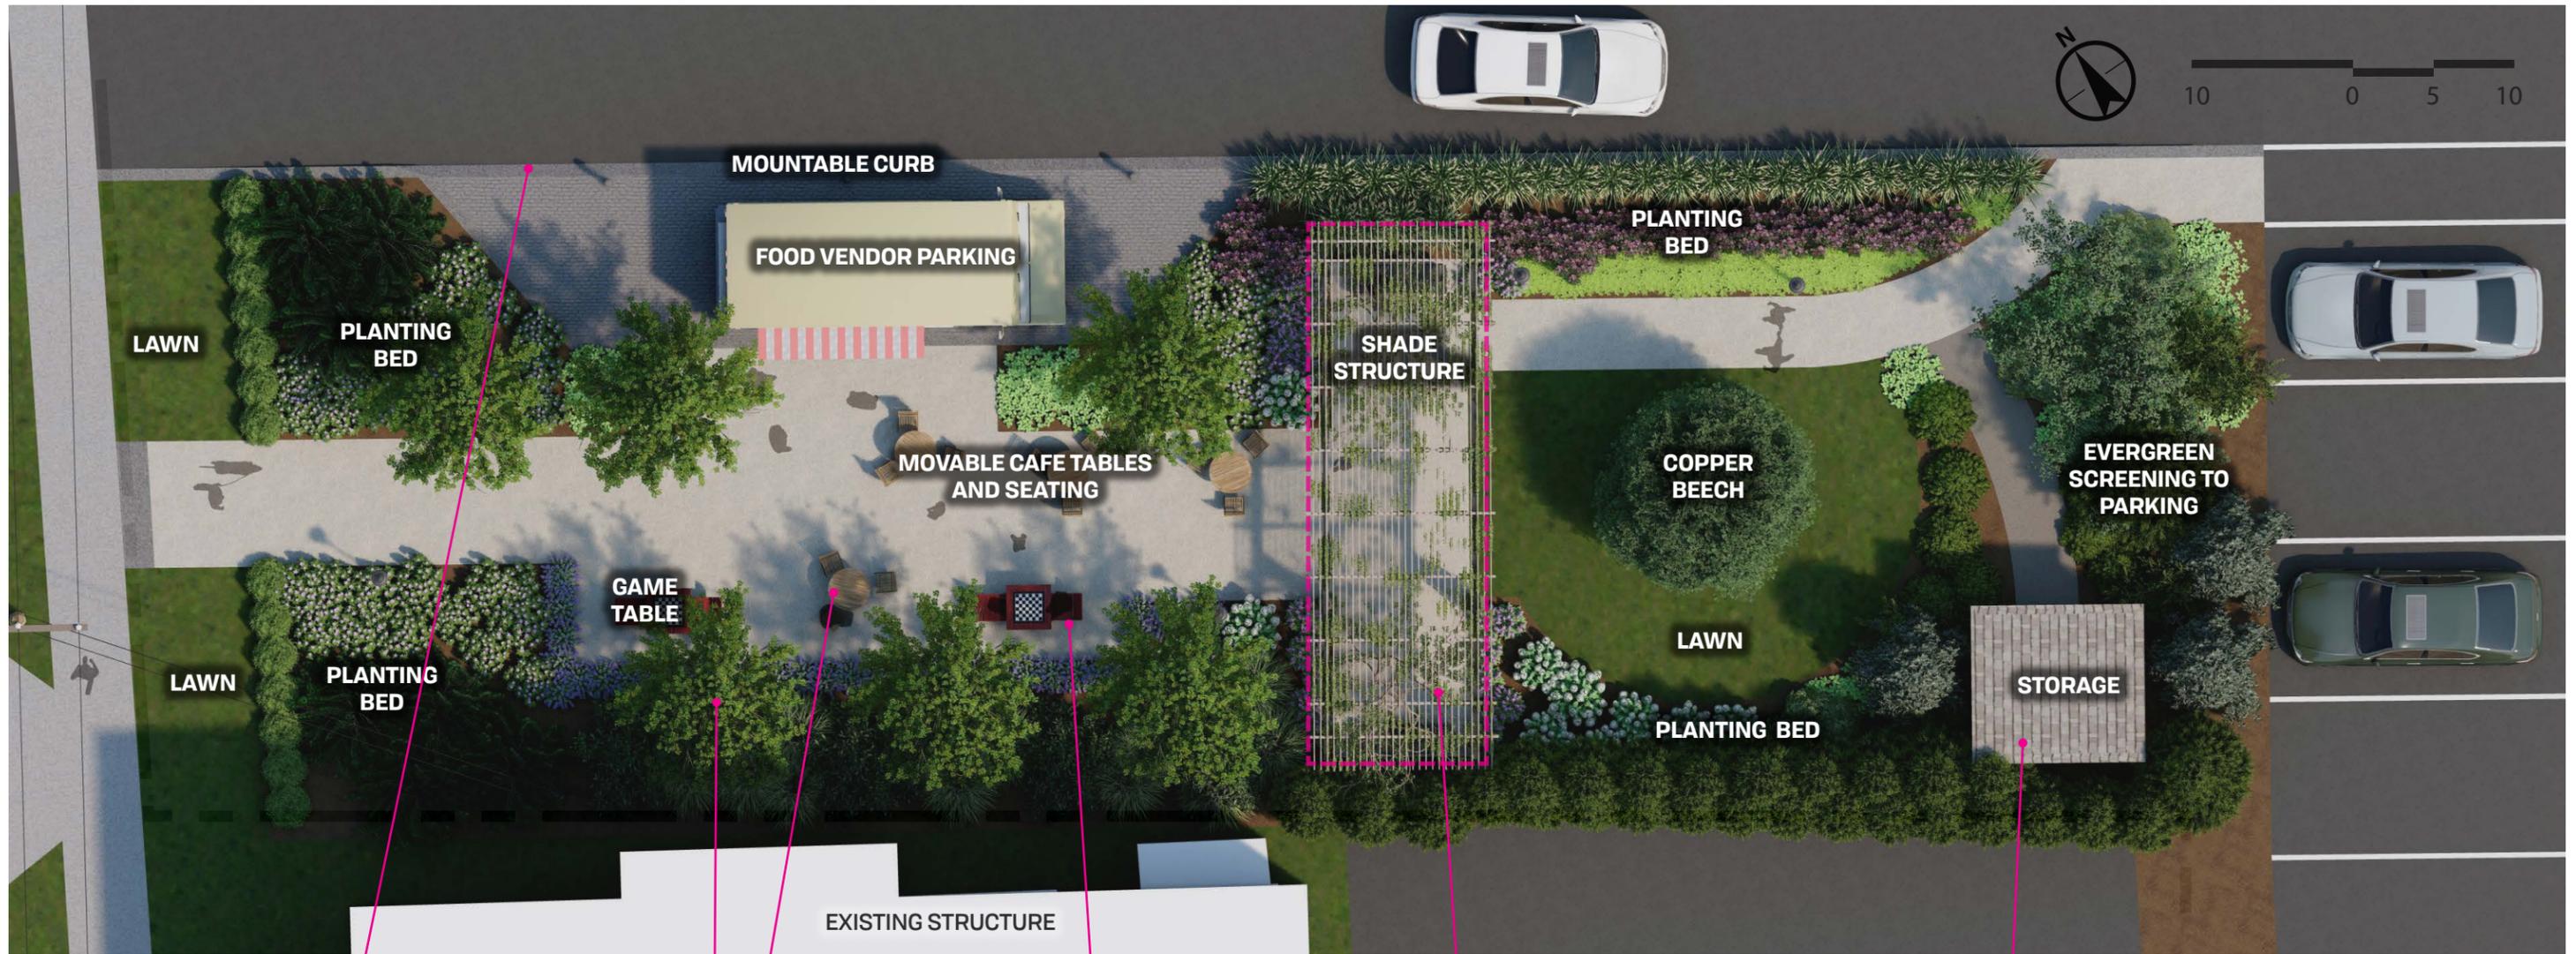
**Site Plan**

**Food Vendor Area**  
Mountable curb with vehicular grade pavement that is flush with surrounding plaza. Access restriction provided with removable bollards

**Allée**  
Columnar trees planted to line walkway, enclose plaza, and reinforce view to Copper Beech tree.

**Cafe Tables**  
Movable cafe tables and chairs for use during vendor hours.

**Game Tables**  
Tables with game board tabletops permanently mounted for use during park open hours.

**Shade Structure**  
Overhead shade structure to frame view to Copper Beech (while young). As the Copper Beech reaches maturity (30+ yrs), the shade structure can be removed.

**Storage Structure**  
Storage area for movable cafe tables and chairs and vendor needs.

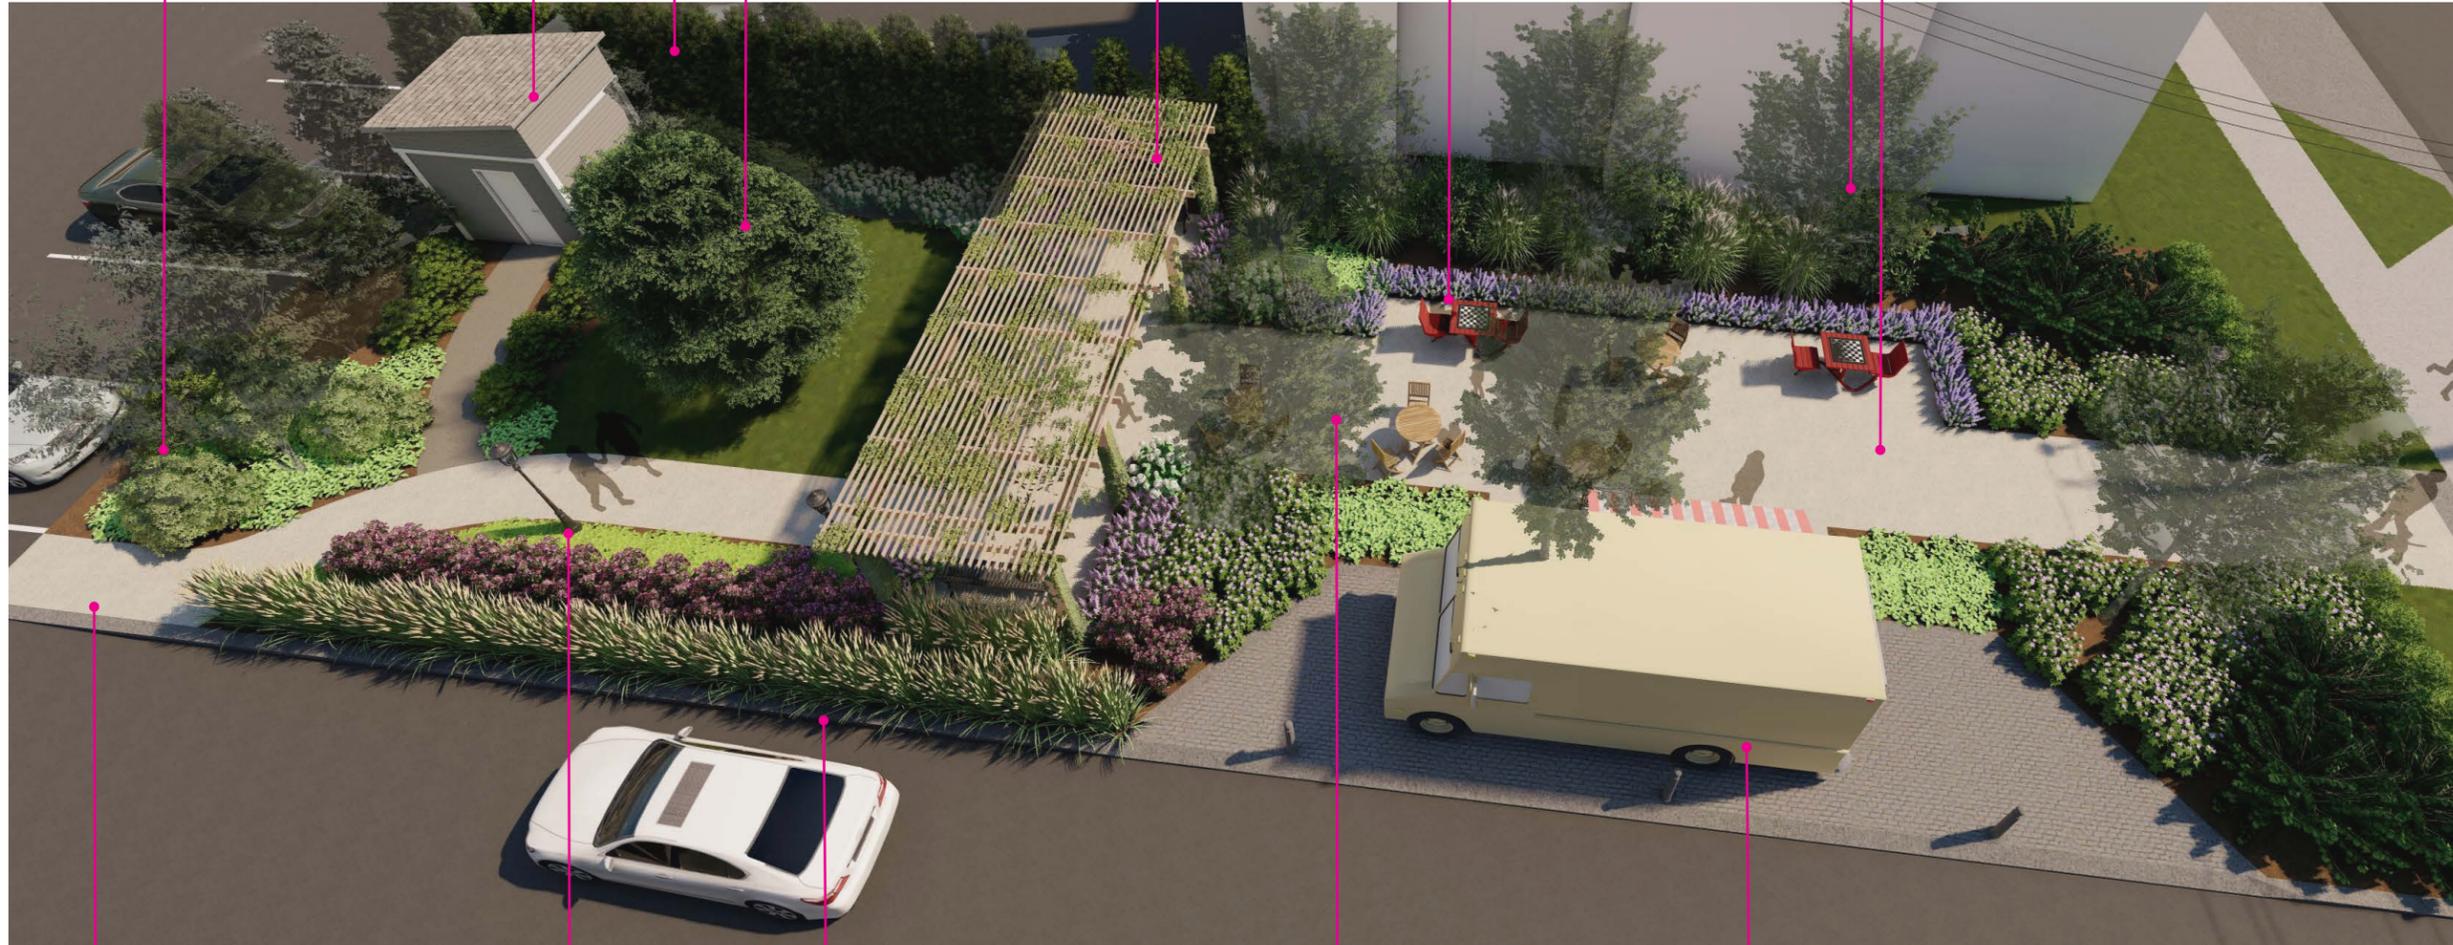
**Illustrative Views**

**Vegetative Screening**

Plantings to buffer views and noise from the adjacent parking lots.

**Storage Structure**

Storage structure (8'x10') for movable cafe tables and vendor needs.

**Copper Beech**

Planted in an expanse of lawn will provides soil volume needed to promote longevity.

**Shade Structure**

Overhead shade structure to frame view to Copper Beech (while young). Vines planted at the posts will provide additional shade cover and create a comfortable seating area beneath.

**Game Tables**

Tables with game board tabletops surface mounted.

**Allée**

Columnar trees planted to line walkway, enclose plaza, and reinforce view to the Copper Beech tree. Spacing to be adjusted to support food vendor service and avoid conflict with overhead utility lines.

**Cafe Tables**

Movable cafe tables and chairs for use during vendor hours.

**Improved Access**

Curb ramp and striped parking stall provide improved pedestrian accommodations and accessibility.

**Post Lights**

Dense plantings to buffer access from adjacent access drive..

**Plaza Patio**

Open paved patio to support movable seating during active food vending periods. With minimal fixed furniture, the park can support additional community programs and events.

**Food Vendor Area**

Mountable curb with vehicular grade parking area (10x35) set flush with surrounding plaza. Access restriction provided with removable bollards if required. The space would continue to support the current vendor (with food cart) and is adequate room to support traditional larger food truck vendors.

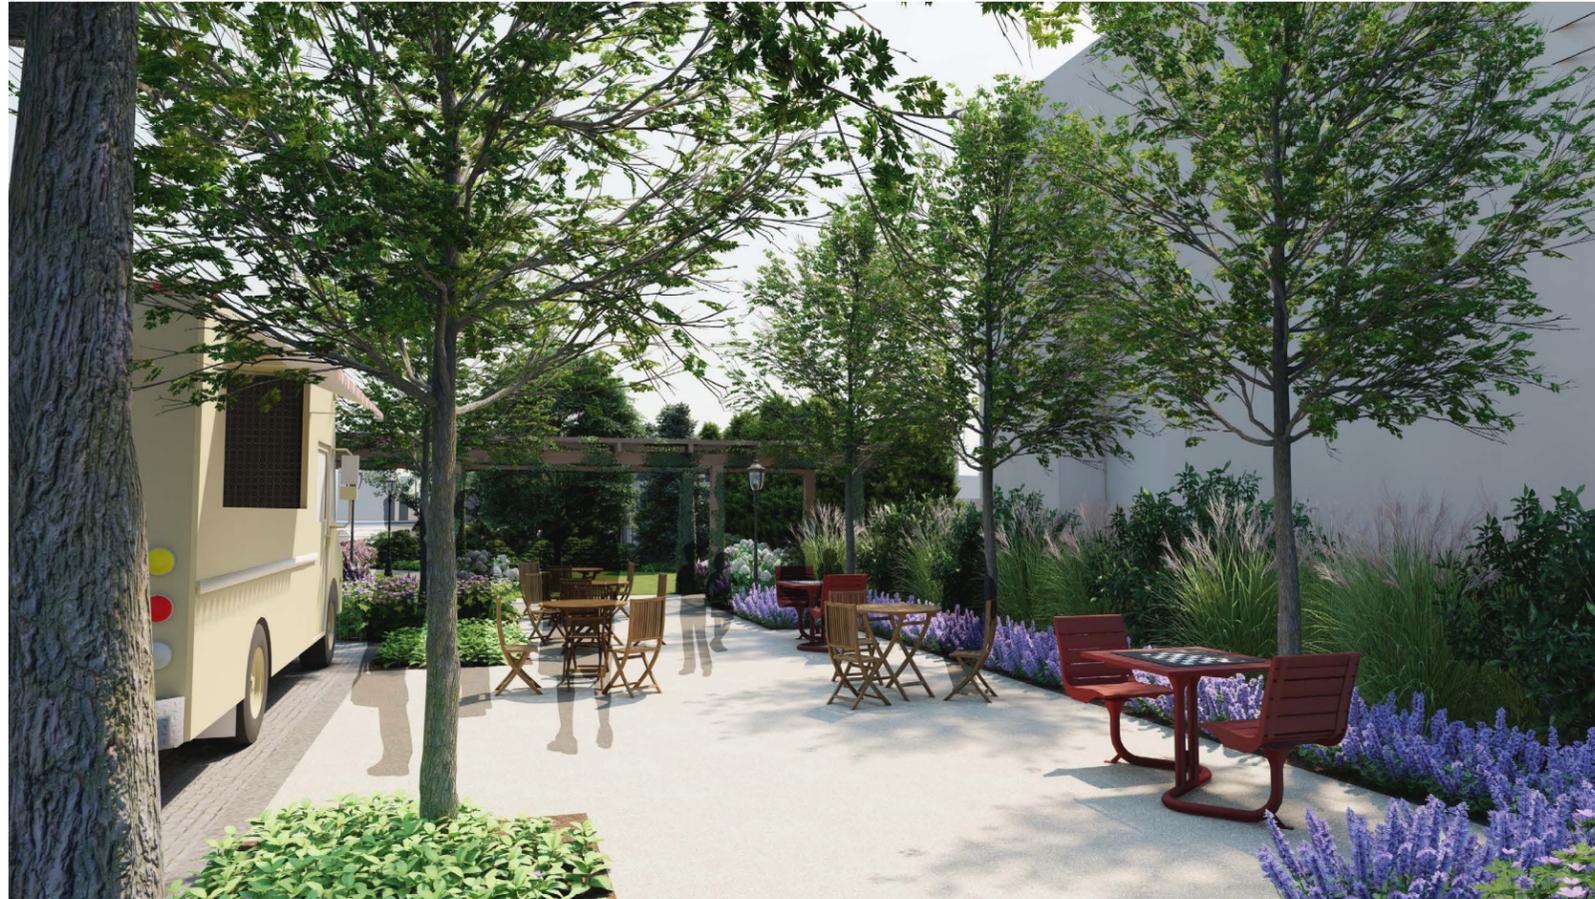
◀ **Option with Pergola Removed**  
Image illustrating the Revised Schematic Design with the pergola excluded in anticipation of budget constraints.
